Thermal leakage detection at the construction site Conca d'Oro Metro B1 in Rome, Italy

Construction site Conca d'Oro Metro B1 in Rome, Italy

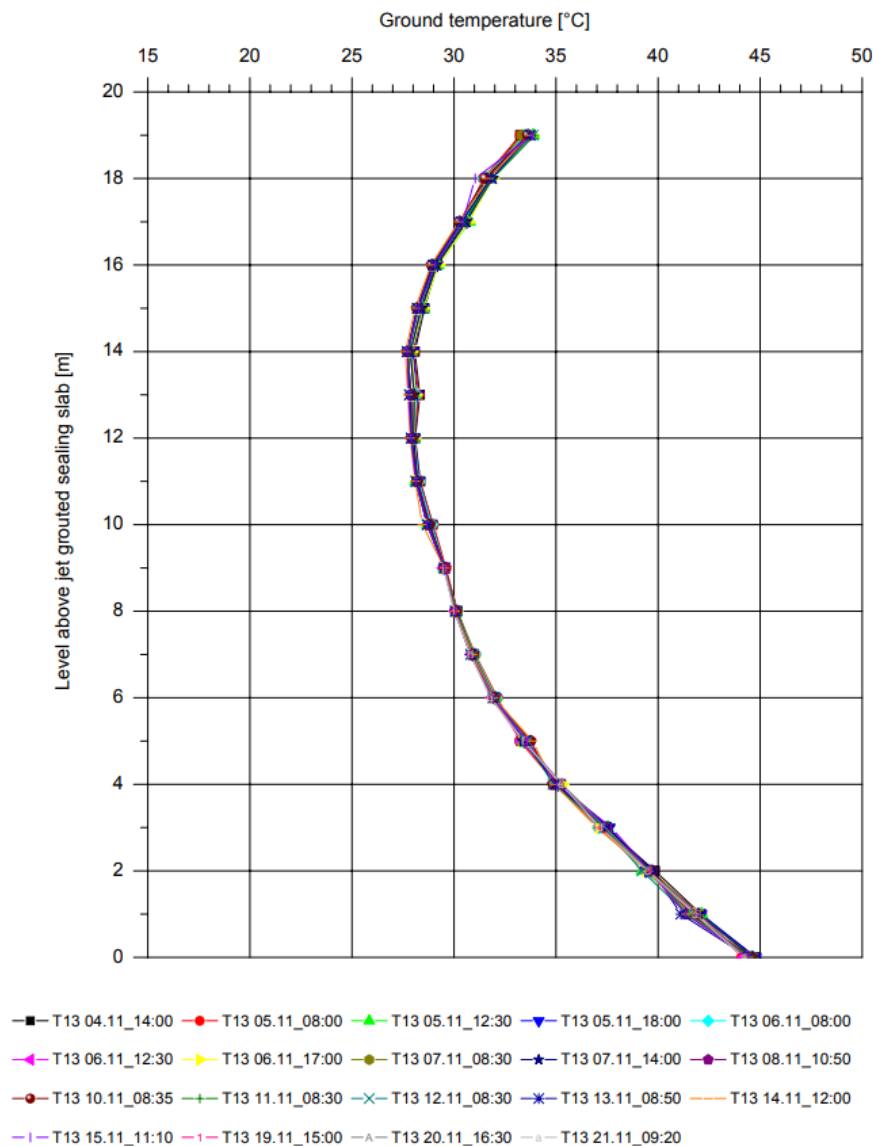
The following diagram is an example of the temporal development of the temperature profiles for the sounding T13 during the pumping test. The depth of 0 m refers to the top of the jet-grouted bottom slab. The temperature depth profiles of T13 do not show any significant temperature anomalies that indicate substantial leaks in the near field of the sounding. In case of a leakage, the affected area would experience a strong cooling of several degrees Celsius. This case is illustrated below with the figure of the sounding T3.

Depth profiles of the ground temperature at the sounding T13

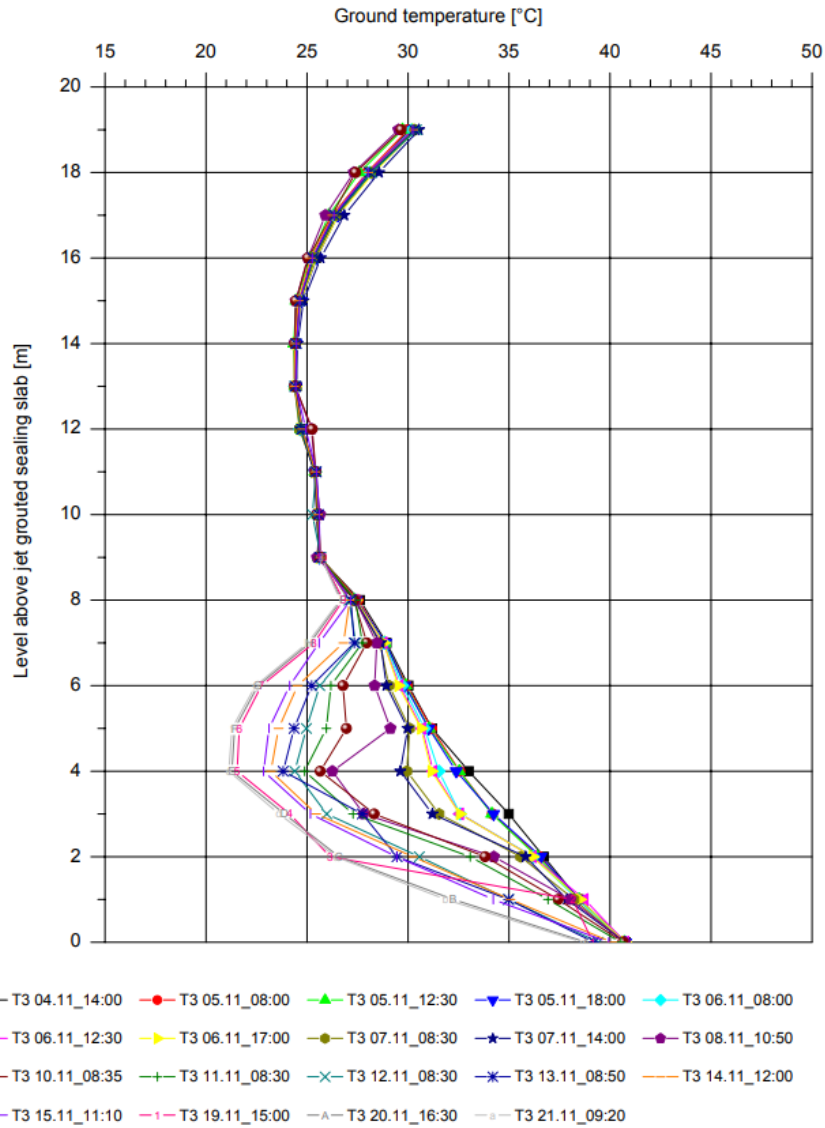
Depth profiles of the ground temperature at the sounding T3 before the rehabilitation. After this measurement the area of the wall was rehabilitated successfully.
