Foundation analysis and restoration of a 13th century church founded on lacustrine clay

Analyse de la fondation et rétablissement de la structure d'une église du 13ème siècle fondée sur des argiles lacustres

P. AMANN, Prof. Dr.-Ing., DGGT, SGBF, SIA, Swiss Federal Institute of Technology Zurich (ETHZ), Institute of
Geotechnical Engineering, ETH Hoenggerberg, CH-8093 Zurich, Switzerland

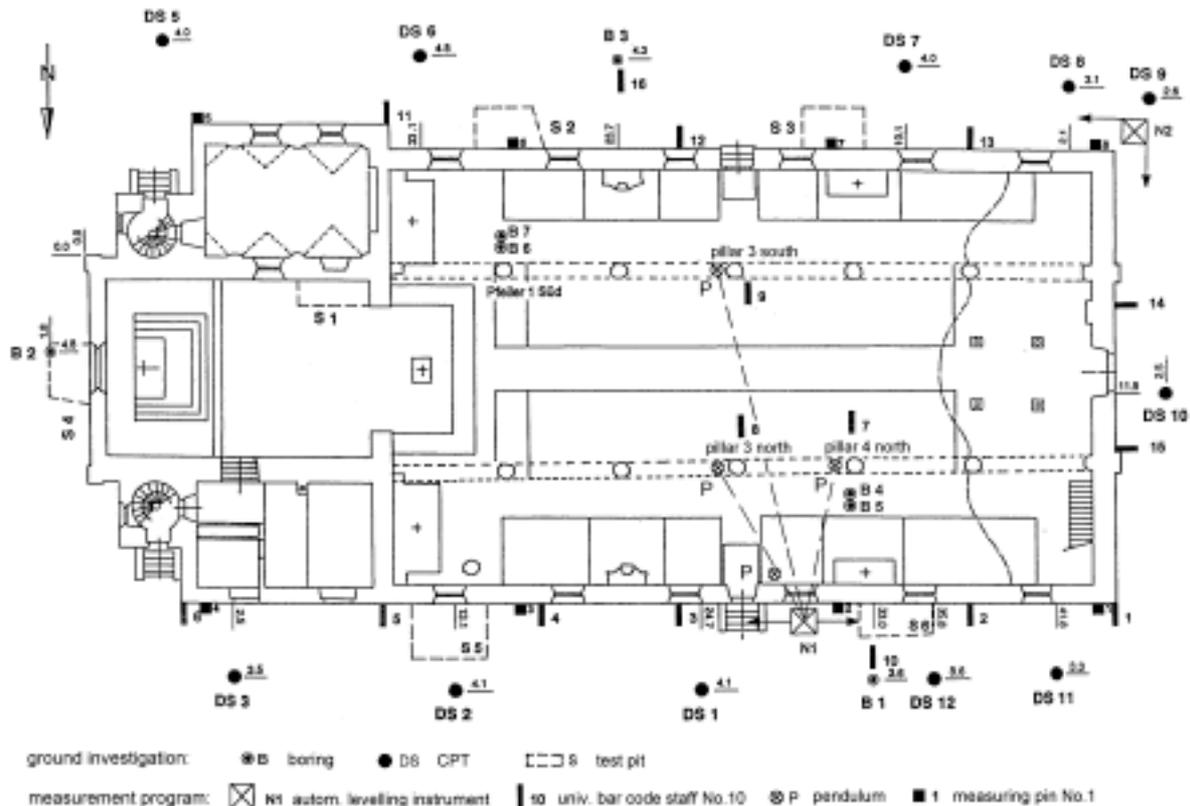
Figure 2. Ground plan Trinity Church, construction ground investigation and measurement program

local construction ground conditions were investigated during the preliminary planning of the restoration by a total of 3 borings with core samples and 12 CPTs (cone penetration test) down to 50 m respectively 30 m (fig 2). The boreholes were equipped with SOLEXPERTS trivec measuring devices, which measure vertical and horizontal deformations (x, y, z) of the ground (Thut 1997) In addition, a system of GLOETZL pneumatic pore water pressure cells was installed.

As a part of the ongoing monitoring, settlement and tilt measurements of the outer facades and of the pillars are carried out (fig. 2). For the monitoring settlement, 11 measuring points on the outer walls and 3 measuring points on the pillars inside the church were selected. At these points universal bar code staffs were installed. The universal bar codes were automatically read according to the given measurement cycle from one of the two automatic levelling instruments, day and night (Amann & Edelmann 2000).

The settlement of the southern wall of the side aisle and the gable wall to the West was measured with the levelling instrument positioned on the outer wall of the south-western corner of the building (fig. 2). The second automatic levelling instrument was mounted on the northern wall. This device also measures the settlement of the three pillars in the interior of the church through a small window. The reference points for the settlement

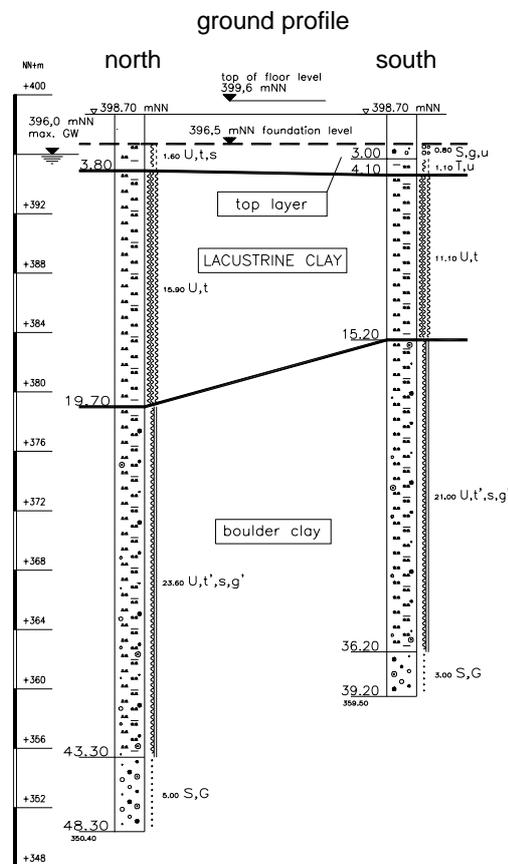
Figure 3. Typical ground profile

The on site investigations agree with the geological expectations down to the level of the expected lateral moraine. The soil profiles near the surface of the northern and southern sides of the structure are, nevertheless, different (fig. 3). Especially two points are of main interest: On the northern side the Lacustrine Clay is approximately 16m but on the southern side it is only about 11m thick. While the natural layers are present below the foundation level on the northern side, these have been covered over by about 1m of construction waste fill on the southern side.

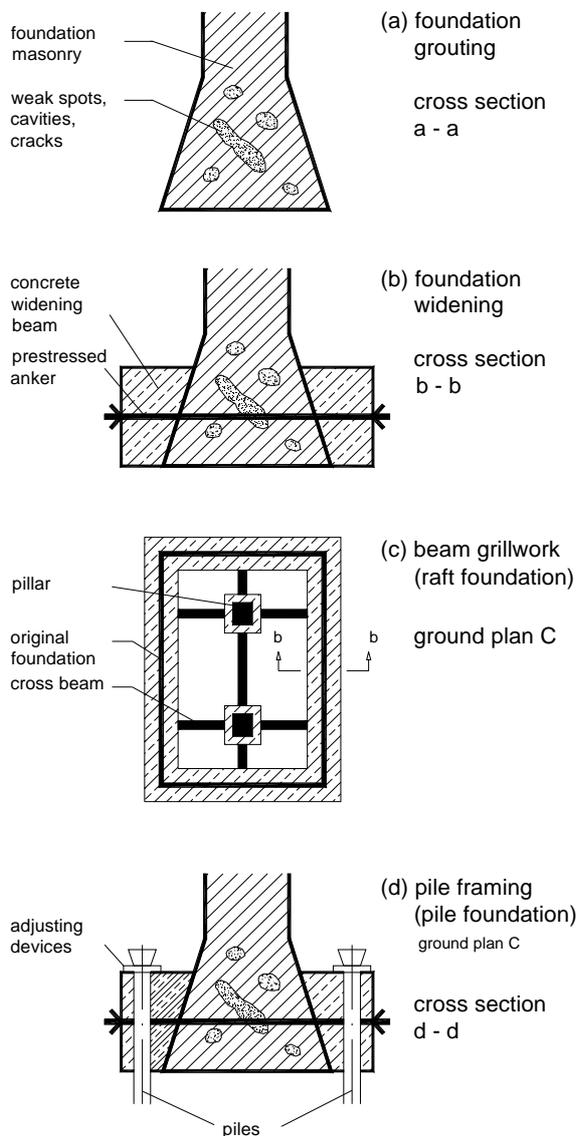
Figure 8. (a) – (d): Different foundation renovation steps

At the present time it can not be evaluated if the actions described in chapter 4.1 are sufficient to obtain long-term safety. Subsequent actions have to be considered in advance. Different possibilities of restoration of the foundations are shown in fig. 8.

Nevertheless, a step-wise procedure based on the observational method seemed to be the most effective approach. According to the extent of deformations observed the following steps involve a completion of the foundation widening and in addition the installation of cross beams. This is tantamount to a new raft foundation (fig. 8 c). Ultimately it could be necessary to place the structure on a pile framing (fig. 8 d) which is also equivalent to a new foundation of the Trinity Church. In this case, the eventual pile head coupling must be planned in advance of the foundation widening. The piles must be prestressed against the beam grillwork in order to guarantee the contact between structure and piles and to anticipate settlements due to the load changes. The most comprehensive solution will be to separate piles and con-

struction by adjusting devices for levelling after differential settlements (fig. 8 d).

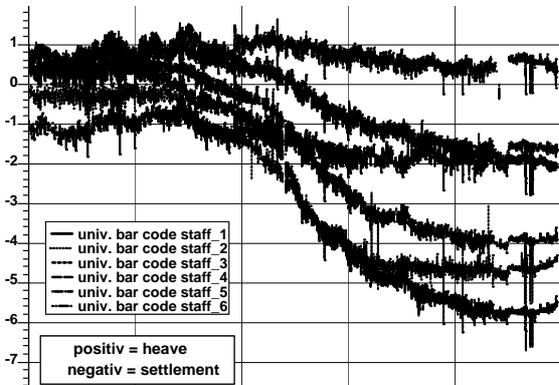
Figure 10. Settlement measurements northern wall

Due to the large deformation of the northern wall the precondition for starting excavation work was the prestressing of the horizontal bracings. Even when the restoration work is carried out in stages, it further reduces temporarily the level of safety. Additional displacements are inevitable. During the construction phase from October 2000 to February 2001 at the northern wall, the settlements have increased to a maximum of approximately 6 mm in the middle between the choir and the gable wall. During that time the inclination of the northern wall increased by about 3 mm (fig. 10).

Altogether, settlements in the amount of +2mm (heave) and -6mm have been measured with the automatic levelling instruments by the end of restoration of the foundation in march 2001.

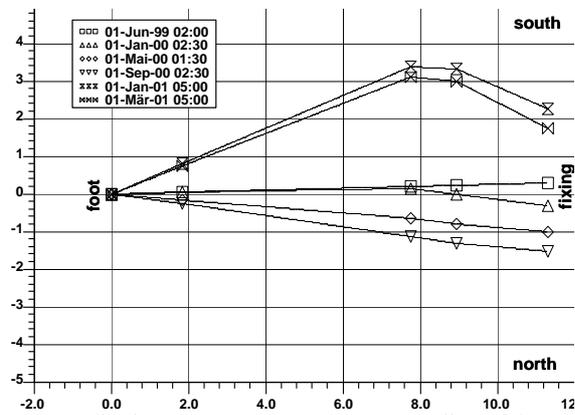
Figure 11. Inclination measurements northern nave wall, pendulum P1

The inclination of the pillars was measured in the range of 1.3mm to 2.4mm towards the north. The prestressing of the horizontal bracings on September 1st 2000 resulted in displacements of approximately 2mm to 3mm in the southern direction and is equivalent to a change of inclination versus reference measurements made on July 1999. So far differential inclinations to a maximum of 8mm have been analysed with the pendulums. Typical measurements are shown in fig. 11 for pendulum P1 at the northern nave wall.
