Thermal leakage detection

Monitoring of the concrete curing temperature at Ilisu Dam, Turkey

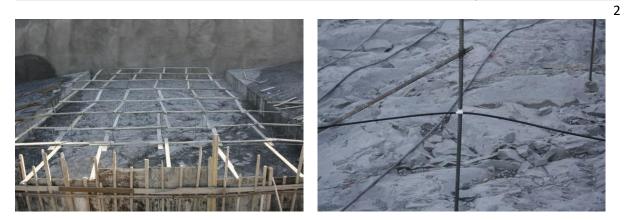
The outflow of hydration heat from the inside of the construction takes a long time and is highly dependent on the distance to the free surface. These sometimes very different temperature conditions can be recorded with this high-resolution technology. To monitor the temperature within the mass concrete, approximately 170 m of fiber optic cable was installed at the Ilisu Dam. The fibre optic cable was easily installed within the fresh concrete. However, fibre-optic cables can be inserted in the concrete in subsequent drill holes, too. In fresh concrete cables can be fixed to auxiliary structures and their spatial position can be measured.

Fixing the fibre optic cable to auxiliary constructions

Along the cable, the temperature evolution induced by curing of the concrete was measured for a period of more than two months in order to assess the state of the concrete blocks for further construction work. The temperature can be measured with a spatial resolution of 0.25 m and 0.1 K. The hydration heat in concrete may lead to thermal tension and cracks. A detailed gathering of the internal temperature distribution of building elements enables the risk assessment of the formation of thermal cracks and the optimisation of the dam construction.
