Monitoring the Nailed Soil Wall at Önzberg

Arno Thut, Daniela Heitz
Solexperts AG, Schwerzenbach, Schweiz; contact@solexperts.com

ABSTRACT: By monitoring a nailed soil excavation wall of up to 15 m height the deformations could be checked and appropriate additional safety measures regarding the local ground conditions could be applied.

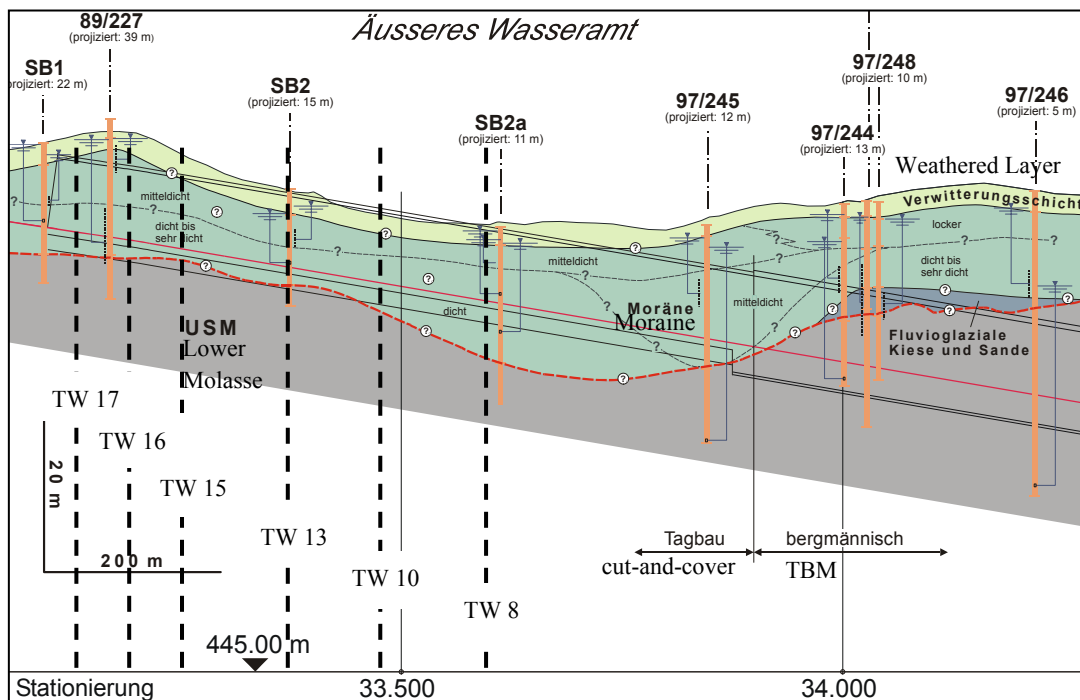
Figure 2. Geotechnical model for the cut-and-cover stretch

From the geotechnical model (Figure 2) it is clear that an 8 to 14.0 m thick layer of moraine is above the Lower Molasse (USM) consisting of sandstone, siltstone and claystone. The deck layer consists of a 2.2 to 2.8 m thick (including humus ~ 0.3 m) weathered layer.

The weathered layer can be considered to be an in situ soil formation, consisting of lightly to strongly silty fine sand (CM, SM) with little gravel, whose in situ density varies from loose to medium dense. In the boreholes SB1 and SB2 SPT values of $N_{30} = 7$ and 27, respectively, have been measured.

The layers of moraine consist for the most part of slightly cohesive fine and medium sand with medium gravel, and in places clayey zones are encountered. The clay fraction amounts to a maximum of 15%. Gravel found in lenses has a grain size between 10 and 60 mm. Stones and blocks were only occasionally encountered in the boreholes (\varnothing up to 20 cm).

On the basis of the SPT tests the moraine exhibits very variable densities. The upper 4.0 m comprise loose soil ($N_{30} = 4$ to 9). Generally though the density increases from medium dense ($N_{30} = 16$ to 33) through dense to very dense ($N_{30} = 39$ to 182) with increasing depth. In the eastern region of the cut-and-cover stretch, however, medium dense conditions are possible down to the bedrock ($N_{30} = 14$ to 29).

After taking into account the above mentioned hazard scenarios the originally planned measuring programme was extended (strain gauges in the nails at 1.0 m spacing, inclinometer and piezometer measurements). Six measuring cross sections distributed along the excavation (Figure 2) were instrumented as shown in Figure 4:

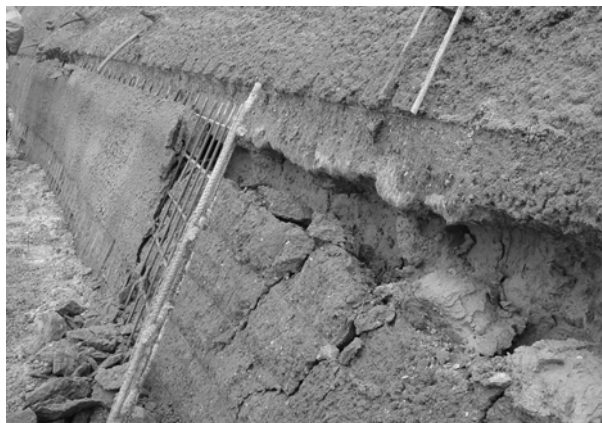
Figure 3. Slumping of the sprayed concrete

- flaking away or slip of soil at the face of the nailed soil wall, probably due to water-bearing layers
- local instabilities at the bottom of the excavation
- potential deep sliding of the soil blocks reinforced with nails
- poor bonding in places between soil and sprayed concrete (Figure 3)

On the north side the settlement of the excavation wall was caused by the steep slope of the wall and partly by the self-weight of the sprayed concrete lining or a lack of bond between the sprayed concrete and the soil. In the bottom stages of excavation the already concreted upper section tended to settle in places.

Finally, the behaviour of the nailed soil wall could be improved and a potential slip in critical areas could be prevented by supporting the self-weight on micropiles for the bottom stages of excavation (Figure 9 and 10).

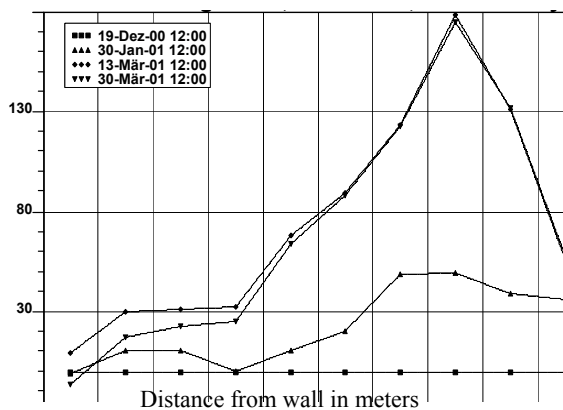
Figure 7. Stress measurements in the nails using strain gauges

The forces in the nails determined from the measurements vary on the whole between 50 and 80 kN, whereas for Nail TW10 KGM S2, (Figure 7) a value of about 200 kN was observed. This may be due to an error in measurement, since the elastic limit of 500 N/mm² would have been exceeded. Other nails, on the other hand, were not activated and did not take up any load (TW10 N2, no figure). Both measuring methods (strain gauges, Figure 7 and compact sliding micrometer, Figure 8) gave similar distributions, whereby the maximum force occurred in the region at the far end of the nail.

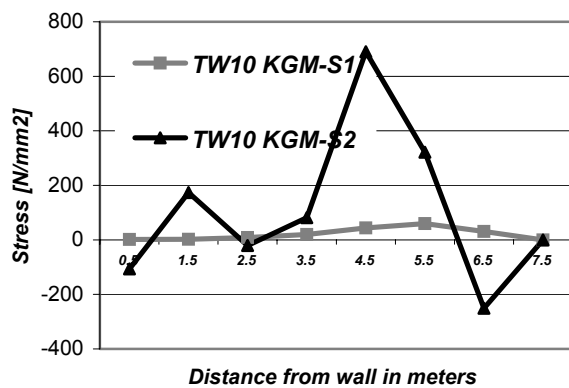
Figure 8. Strains in the nails converted to stresses with TW10 KGM S1 and S2.

The visual observations show that the nails follow the relatively large displacements, i.e. the head of the nail moved up to ~100 mm and thus the friction forces would have been fully mobilised. The summation of the observed strains with KGM S1 amounts to 3 mm, that of KGM S2 to 5 mm.
