# Design and realisation of the PRACLAY experimental gallery

Wim BASTIAENS - Scientific manager at EIG EURIDICE

Alain VAN COTTHEM - Project manager at TRACTEBEL Development Engineering

Tony VOORSPOELS - Director at SMET Tunnelling

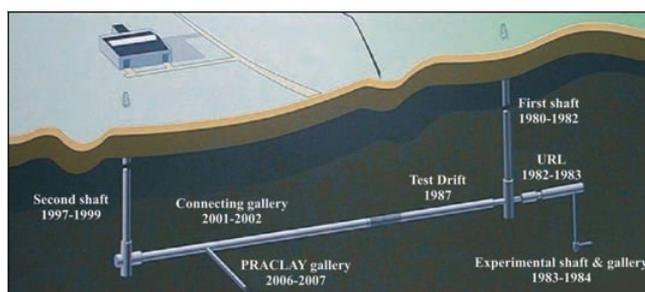
Figure 1 - Construction history of HADES

The first construction phase started in 1980 and since then HADES has been expanded several times, Figure 1 shows the construction history (Bastiaens & Bernier, 2006). The primary purpose is conducting various in-situ experiments (on geomechanics, corrosion, migration, ...) to study the safety and feasibility of HLW disposal in the Boom Clay layer. HADES is currently managed by the EIG EURIDICE, an economic interest grouping between SCK•CEN and ONDRAF/NIRAS (the Belgian agency for radioactive waste and enriched fissile materials).

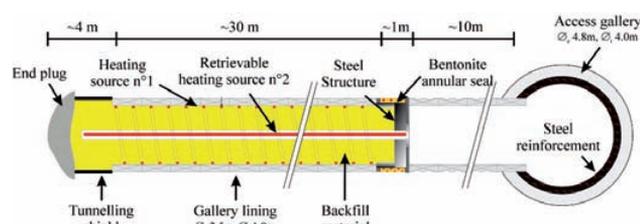
Figure 2 - Overview of the PRACLAY heater test

The heater test focuses on the response of the host rock to the thermal load. Figure 2 shows the experimental lay-out. In 2007, an important milestone was reached with the realisation of the PRACLAY gallery; a 45 m long drift with an external diameter of 2.5 m. The design was made by TRACTEBEL development engineering. Following an adjudication procedure, the construction contract was awarded to SMET Tunnelling. The design of the gallery needed to meet the specific requirements related to the heater test.

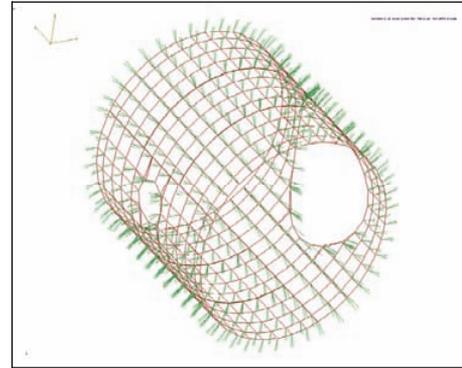
Figure 3 - Finite element model of the reinforcement structure

The calculation was done by finite elements. The concrete lining is neglected due to the loss of the pre-existing normal force when the opening is created. The interface elements are reduced to equivalent springs based on the Boom Clay deformation modulus. The large opening of the structure undergoes centimetric deformation under these high loads so that an extra height was foreseen in order to guarantee the passage of the tunnelling machine. Figure 3 and 4 show the model and the bolting principles.

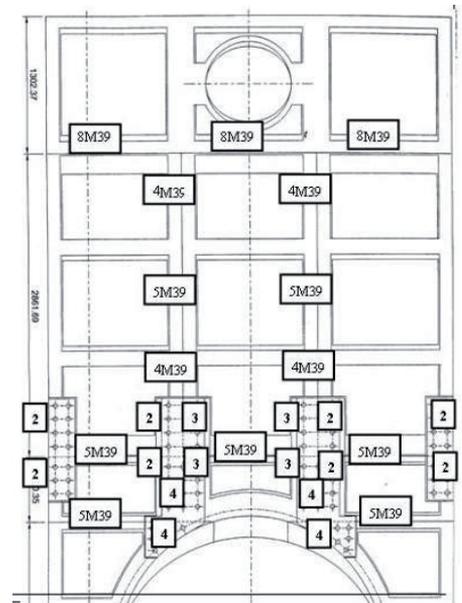
Figure 4 – Detail of the bolts and additional plates

The structural principle is based on several ribbed plates bolted with a significant number of M39 bolts (strength 10.9), locked in place by means of a predetermined tightening torque. The bolts are highly stressed due to the shear and tensile forces acting on the assemblies. Additional plates were added to increase the overall stiffness, mainly near the large opening.

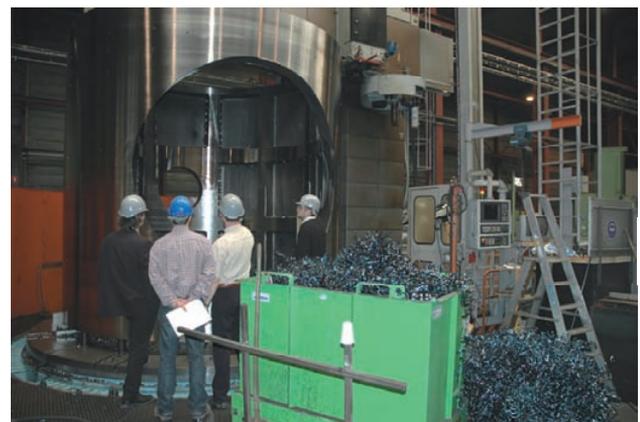
Figure 5 – Milling of the reinforcement structure as a whole

SMET Tunnelling subcontracted the manufacturing of the structure to Allard Europe. It is composed of 11 cast steel segments. The first step was the construction of positive wooden moulds. These were made bigger than the designed size to compensate the shrinkage of steel. Then negative moulds were made in sand and the segments were cast. Afterwards, the segments were sandblasted and machined. Finally, the ring was assembled and milled as a whole (see Figure 5).

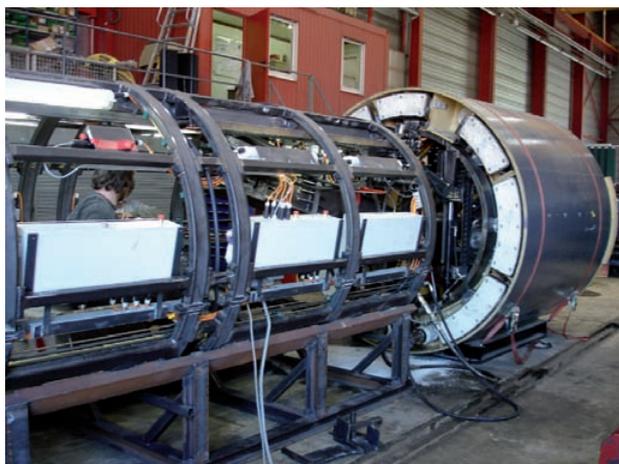
Figure 6 – Test assembly of the tunnelling equipment

The machine was constructed by SMET. Prior to the transport to the underground facility, all tunnelling equipment (shield, roadheader, erector, rail tracks and hydraulics) was assembled in the same configuration as for the actual excavation (see Figure 6). This allowed checking all functions and the geometry of the machine, separately and as a whole. It provided an opportunity to make any necessary adjustments before starting the underground works. The test assembly was all the more needed due to the limited assembly space in the connecting gallery. Amongst others, the manipulation of a lining segment and the insertion of a key into the corresponding pocket of the shield were tested.

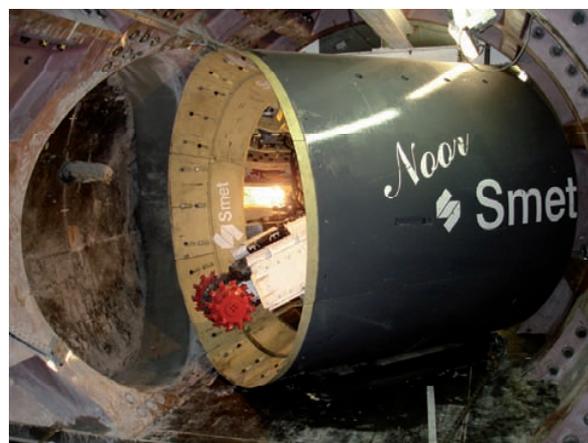
Figure 7 – The tunnelling shield as it is being positioned into the reinforcement structure: the roadheader (painted red) is visible at the front of the tunnelling shield; Boom Clay is visible in the opening of the reinforcement structure

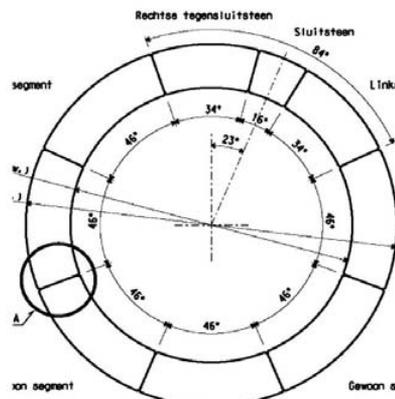
Figure 8 – Cross section of the PRACLAY gallery lining

A ring consists of 8 concrete segments and one shorter wedge shaped key segment (see Figure 8). The introduction of the wedge expands the ring against the circular excavated profile inducing a post-stressing effect in the lining. The 30 cm thick concrete segments are unreinforced and unbolted. Each ring is independent and 50 cm in width. The key segments were 58 cm wide and were sawn to the correct dimensions on site. Depending on the diameter of the excavated profile behind the tunnelling shield, the front or rear end of the key segments was removed. This way a larger range of possible lining diameters was covered: 2488 – 2502 mm.

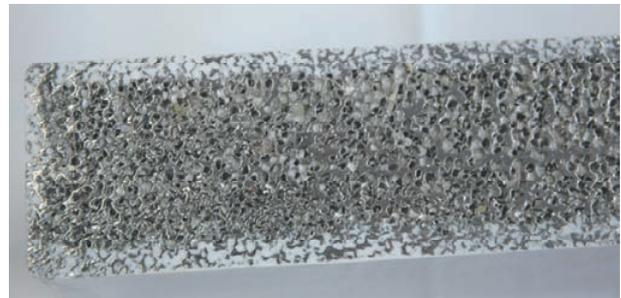
Figure 9 – Cross section of a stainless steel foam panel

The material chosen and tested is a specific stainless steel foam panel. This material was developed in cooperation with PORVAIR, which also produced the panels. Figure 9 shows a cross section of such a panel. Its stress-deformation behaviour is shown in Figure 10. Because very large forces are needed to compress these panels, the compression test shown had to be performed using a press not specifically designed for this purpose. Consequently, the resolution of the test is low. However, the desired behaviour is illustrated: the flat zone of the curve at 40 MPa corresponds to the heat loading phase, limiting additional stresses in the concrete and hence protecting its integrity.

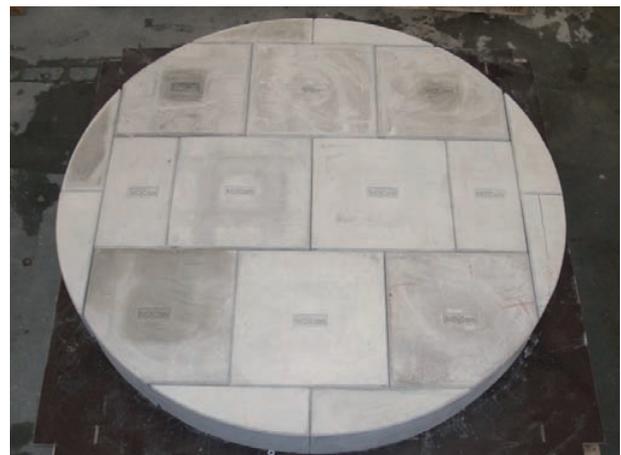
Figure 11 – Test assembly of the wall of compressive concrete which was installed at the end of the PRACLAY gallery, the diameter of the wall is 2.4 m and its thickness 0.25 m

- The diameter of the end plug is 1 m larger than that of the gallery itself. Consequently, the outer annulus of the plug is in contact with the clay and a reaction force will be created in this zone when the formation exerts pressure on the end plug.
- Furthermore, a custom made wall of compressive concrete blocks was built between the shield and the end plug (see Figure 11). The initial thickness of the wall is 25 cm. This material was designed and manufactured by SOLEXPERTS, based on HIDCON elements also used in other tunnelling projects (e.g. Lötschberg). The concrete's behaviour is elasto-plastic with a specified yield level between 2 and 4 MPa (see Figure 12). The material was tested under the expected conditions i.e. at 90 °C, confined and fully saturated.

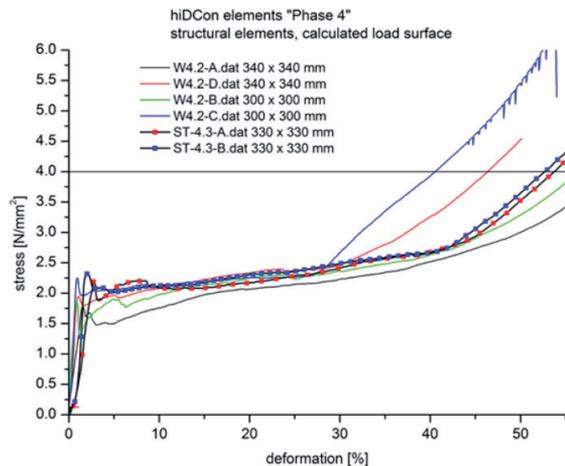
Figure 12 – Stress-deformation tests on compressive concrete.

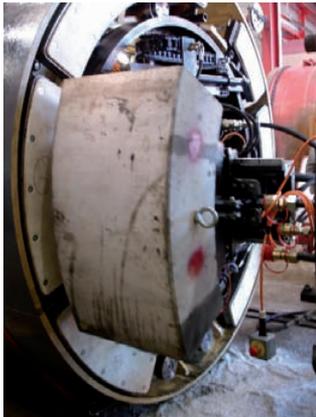
Figure 13 – Segment manipulation with the rotary erector

Several excavation steps (~15 cm each) were performed up until an unsupported zone of some 60-70 cm was present behind the tunnelling shield. Next, the lining segments were installed by using a rotary erector mounted on the rear of the tunnelling shield (see Figure 13). The installation started with the bottom segments. In the meanwhile the key segment ("wedge") was installed in a dedicated pocket in the tunnelling shield. Once all other segments were in place (the top ones were kept in place by the hydraulic jacks of the shield), the key segment was pushed into the ring, expanding it against the excavated clay profile. The contact surfaces of the key segment and the adjacent counter key segments have a helicoidal shape, ensuring a correct positioning of the key segment as it is pushed into the ring.

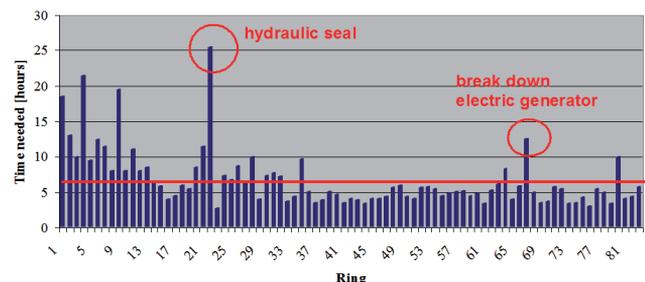
Figure 15 – Time needed for each lining ring: the targeted excavation rate was reached most of the time

This was also reflected in a lower progress rate than achieved during the excavation of the connecting gallery. Figure 15 shows

the time needed for the excavation and installation of each ring. Taking into account the width of the lining rings (0.5 m) the target rate of 2m/24h corresponds with a maximum of 6h/ring. The graph shows that after a (expected) start-up zone of 5-10 m, the target rate could be reached about 90% of the time. There were two major exceptions. The first was the zone where a special structure was installed for the future construction of a hydraulic seal needed to seal off the PRACLAY heater test from the rest of HADES. A second one was related to a break down of an electrical generator.

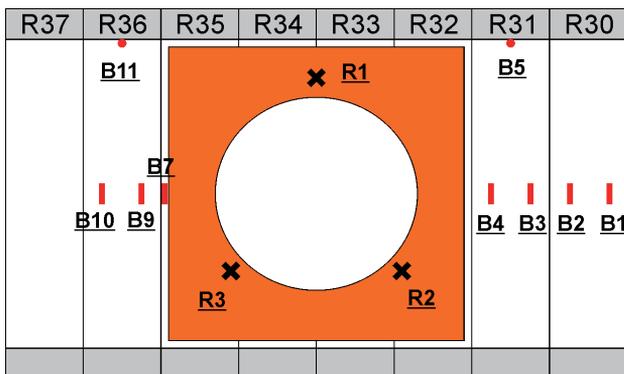
Figure 16 – Location of strain gauges at the gallery crossing

Due to the excavation of the PRACLAY gallery, a stress redistribution occurred. In some places stresses were lower than before, but in other places the stress level increased. At the level of the crossing, the ground pressures were borne by the steel reinforcement structure. In order to evaluate the behaviour of the crossing, it was equipped with strain gauges. Due to the relatively limited length of the reinforcement structure, the connecting gallery lining beyond the reinforced zone (rings 32-35) could also experience an increased load. Therefore additional reinforcement was available and the lining of the connecting gallery was monitored to evaluate whether it was necessary to actually install them. Ring 30 of the connecting gallery was built with segments containing embedded strain gauges. Moreover strain gauges were fixed on the intrados of the connecting gallery lining close to the reinforcement structure. Figure 16 shows the location of the surface strain gauges at the gallery crossing.

As expected, the highest stresses in the steel structure were measured near the 2.5 m diameter opening, at locations R2 and R3 (see Figures 16 and 17). They amount up to ~300 MPa. The graph shows that stresses increased in two steps. The first step corresponds to the removal of the connecting gallery lining at the level of the 2.5 m opening. The second increase occurred when the excavation actually started. If one looks into detail, the second increase consists of several smaller steps, these correspond to the alternating steps of excavation and lining installation.

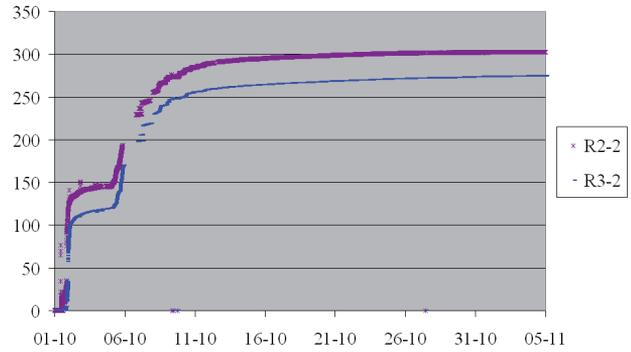
Figure 17 – Stress measurements [MPa] on the reinforcement structure during the excavation (locations R2 and R3)

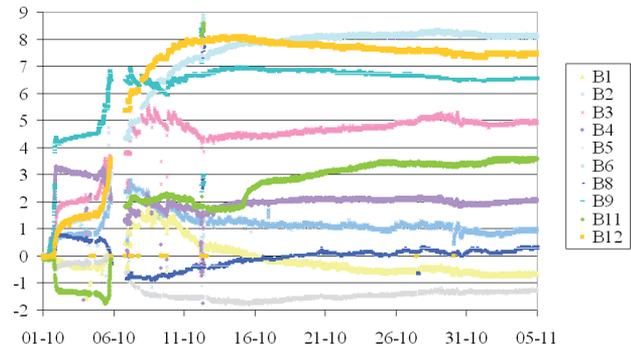
Figure 18 – Stress measurements [MPa] on the concrete lining next to the reinforcement structure

Similar results were obtained by the strain gauges installed on the surface of the concrete lining next to the reinforcement structure (see Figure 18). The same two events are visible: removal of the lining and start of the excavation. Maximum stress increase measured was some 8 MPa.

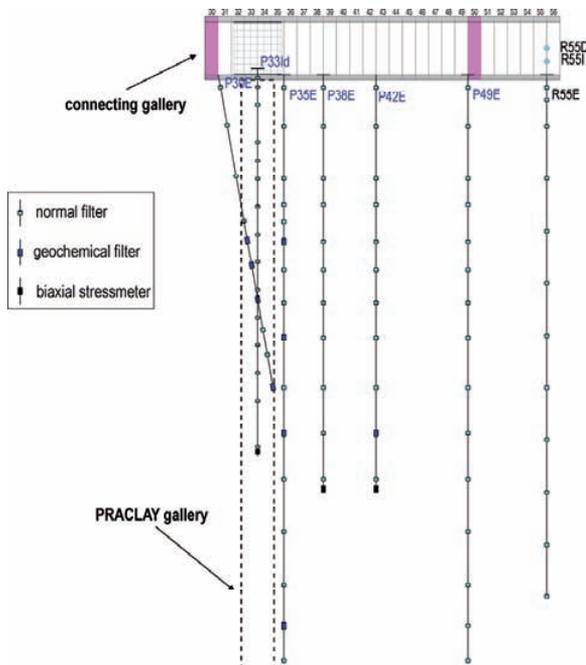
Figure 19 – Lay-out of the piezometers installed around the PRACLAY gallery

Prior to the excavation of the PRACLAY gallery several types of sensors were installed in the surrounding host rock. Measured parameters include pore water pressure, total stress, displacement, temperature, pore water chemistry and seismic parameters. In total, eleven boreholes were drilled and equipped from the connecting gallery, some up to a depth of 45 m. Because these sensors were already installed before the construction of the gallery they registered the HM response of the Boom Clay during the excavation. When looking at the HM behaviour of a clay formation, one of the important and highly sensitive parameters is the pore water pressure. Figure 19 shows the locations of all installed pore pressure sensors; this article will discuss the results of one specific example.

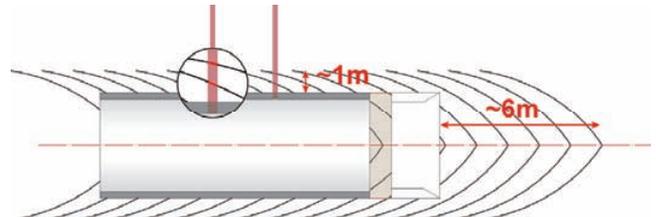
Figure 21 – Fracture pattern observed during the excavation of the connecting gallery

During the excavation of the connecting gallery, a fracture observation programme was carried out. This resulted in the description of the herringbone-like fracture pattern shown in Figure 21 (Bastiaens et al., 2007). A similar observation programme was carried out during the excavation of the PRACLAY gallery. The front and excavated profile of the gallery were observed and photographed systematically. The detailed analysis of the gathered information is currently ongoing, the first results indicate a similar fracture pattern than observed before. Figure 22 shows the excavation faces of the PRACLAY and connecting gallery. In both cases, conjugated fracture planes are present that meet each other at the middle of the gallery. As expected, a more complicated situation was encountered near the crossing.

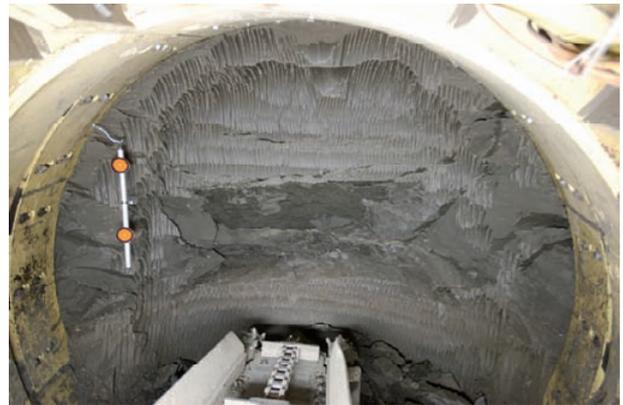
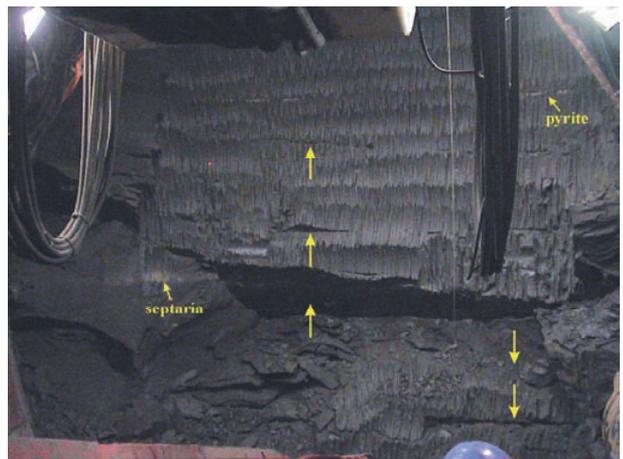
Figure 22 – Excavation face of the PRACLAY gallery (top) and the connecting gallery (bottom)

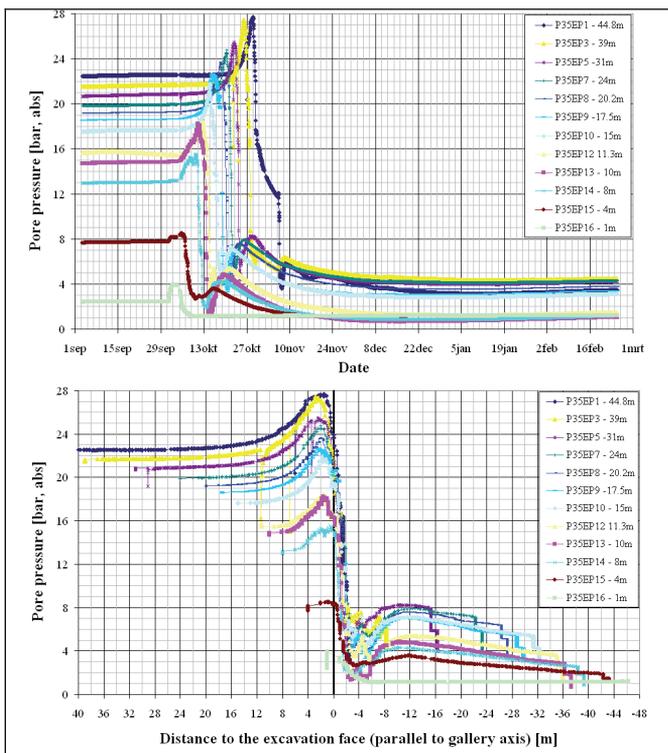
Figure 20 – Pore pressure measurements at P35E as a function of time (top) and the relative position of the sensor (bottom)

Figure 20 shows the pore pressures measured by piezometer P35E which runs parallel to the PRACLAY gallery, at a distance of only 0.7 m. Sixteen measurement points are present, at distances between 1 (sensor 16) and 45 m (sensor 1) from the connecting gallery. Figure 20 shows two graphs. The one on the top shows pore pressure measurements at piezometer P35E as a function of time. The other graph shows the same measurements but as a function of the relative (horizontal) position of the sensor with respect to the excavation face.

Before the start of the excavation, the pore pressure values largely depend on the distance between the sensor and the connecting gallery. Indeed, the disturbed zone of the connecting gallery regarding pore pressures has an extent of several tens of metres (Bastiaens et al., 2006). According to the elasto-visco-plastic theory, the variation of the pore water pressure during the underground excavation is linked to the volumetric deformation of the massif via the coupling effect. For all sensors in Figure 20 pore pressure rises when the excavation front approaches that specific sensor. When the front is at about 2 m, pressures start to decrease. Some metres after the front has passed the sensor, pressures increase and later decrease again.

The first increase is attributed to the undrained contractant behaviour of the clay. Stresses increase ahead of the front, compressing the clay (decrease of pore volume). Since the clay's very low permeability, water can only be expelled very slowly and the pore pressure increases. The drop phenomenon close to the front results from the high decompression of the massif and the accompanying fractures and volumetric dilatations (increase of the pore volume). Once the lining is placed (about 3 m behind the front), reconsolidation starts. Similar observations were made in the CLIPEX project studying the HM response during the excavation of the connecting gallery (Bernier et al., 2002).

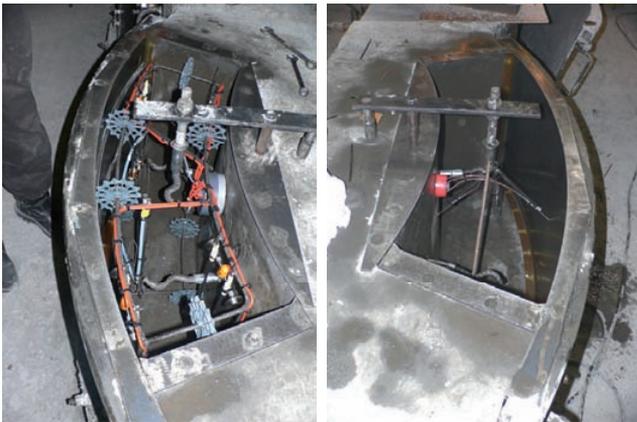
Figure 23 – Segment moulds equipped with vibrating wire strain gauges (left) and thermocouples (right) prior to concrete casting

About 40% of the lining rings contain one or more specially equipped segments. In some segments, sensors were embedded during the manufacturing: thermocouples, strain gauges (vibrating wire and optical), pressure cells and load cells. Some segments contain corrosion samples and some lining rings were equipped for wire extensometer measurements. Figure 23 shows some pictures of the manufacturing process of the instrumented segments.

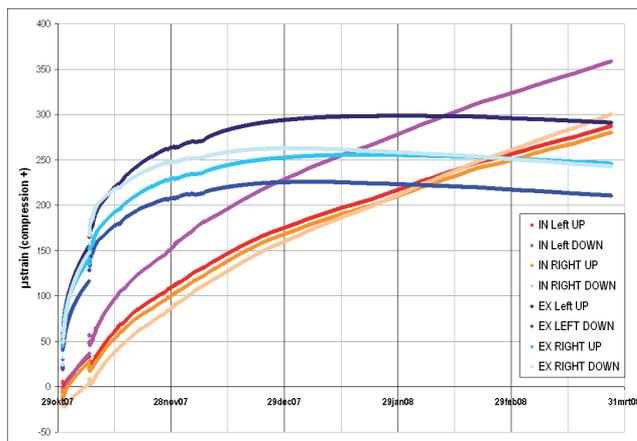
Figure 24 – Strains inside the PRACLAY gallery lining, measured by embedded strain gauges in ring 77

Figure 24 shows strain measurements by embedded strain gauges in one of the segments of ring 77 of the PRACLAY gallery, notably the utmost right segment. Ring 77 is one of the high strength rings (CERACEM®) near the end of the gallery. This segment contains eight vibrating wire strain gauges, four near the extrados (blue graphs) and four near the intrados (orange/pink graphs). At present, measured strains are between 200 and 360  $\mu$ strain. According to the technical specifications of the concrete, Young's modulus should be about 65 MPa. The measured strains thus correspond to stresses between 13 and 23 MPa. Tests to verify the value of Young's modulus will be carried out on concrete cores taken out of some spare segments.

Due to the progressive loading of the lining by the surrounding clay formation strains increase rapidly during the first weeks. About one week after the start of the measurements, the effect of restarting the tunnelling works after the stop test is visible. The sensors near the intrados behave differently than those at the extrados: a varying bending moment is present inside the lining. Other segments (at other positions inside the lining) show a different behaviour. The results reflect the transition phase towards a stable loading of the gallery by the clay formation. For the connecting gallery, a more or less stable loading was obtained after roughly 12 months.

Generally, the strains show a continued increase up to present. At least part of this continued increase is caused by creep of the concrete. Therefore, creep tests are being carried out on concrete cores to quantify this phenomenon and enable a correct interpretation of the stresses within the lining.
