Fibre Optic Leakage Detection System Merowe Dam, Sudan

Merowe Dam, Sudan

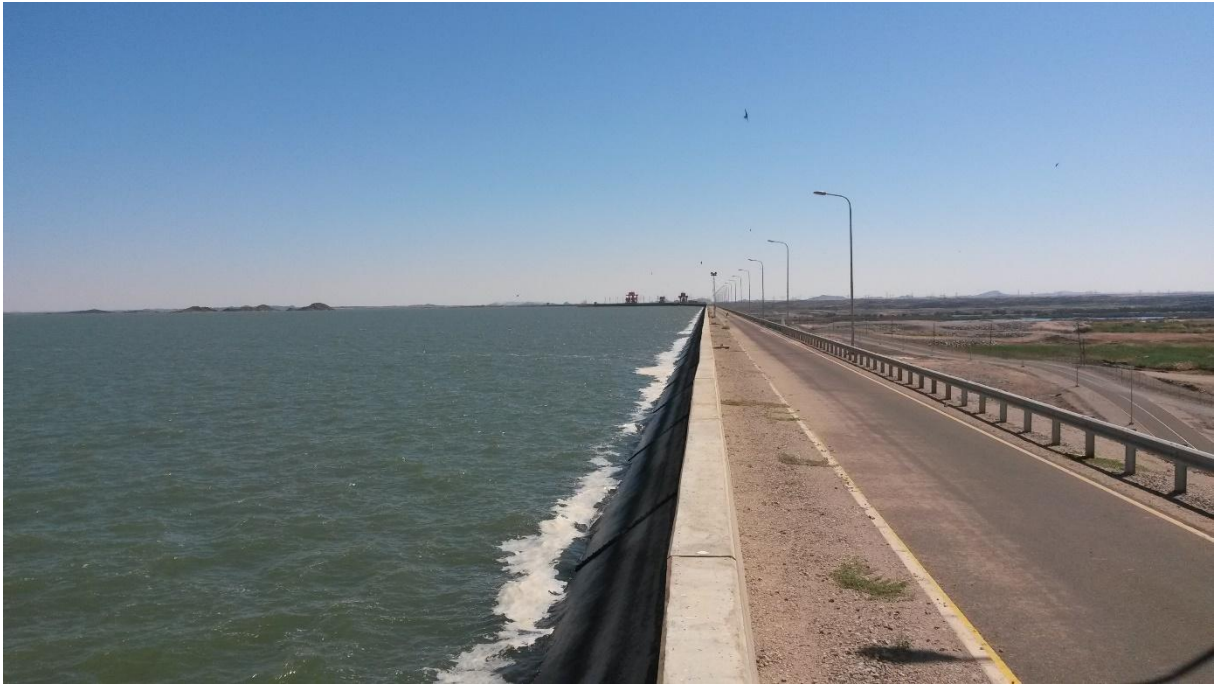
The Merowe dam is located on the Nile, about 350 km north of Khartoum. With a storage volume of approx. 8.2 billion m³ of water it is Africa's largest contemporary hydropower project. It is used for power generation, irrigation and flood protection. The dam consists of several sections: the main dam is a rockfill dam with a core seal and on both sides of the valley are rock fill dams with a concrete surface (CFRD).

For a reliable and a cost-effective monitoring of the sealing system's functionality, approximately 7000 m of hybrid fibre optic cable was installed below the copper water stop at the upstream dam toe. The monitoring system has a local resolution of 0.25 m and a temperature resolution of 0.2 K. This allows the exact localisation of a possible failure of the copper water stop.
