1

Fibre optic leakage detection system – Peak District National Park, United Kingdom

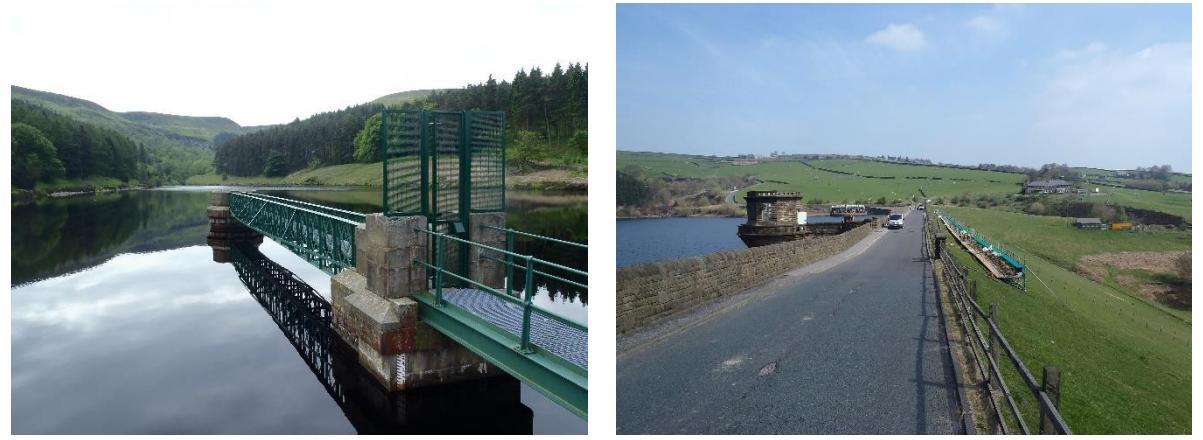
Embankments at Riding Wood Reservoir (left) and at Digley Reservoir (right), United Kingdom

The **Riding Wood Reservoir** was originally constructed in 1878 and has a storage volume of 235.000 m³. An approximately 21 m high earth fill dam with a clay core impounds the reservoir. Riding Wood is one of the four reservoirs that supply Holmbridge Water Treatment Works. Temperature sensors were installed in 2012 on the downstream side of the clay core. They were set up for the usage as long-term leakage monitoring system. The aim of the monitoring system is to detect possible seepage water passing through the clay core. For this purpose, 1090 m fibre optic hybrid cable was installed. For the Heat-Pulse-Method two components in the cable are important: the optical fibre as temperature sensor and the copper wires for the heating.

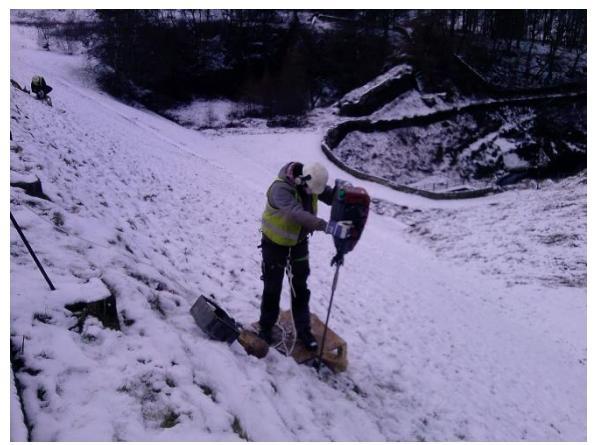
Installation of the temperature sounding at the embankment of the Riding Wood Reservoir

Nine soundings were rammed vertical into the ground along a 117.5 m section of the embankment. In the process, depths of up to 19.5 m were reached. A reference measurement was carried out in June 2015, which can be used as comparison to following measurements.

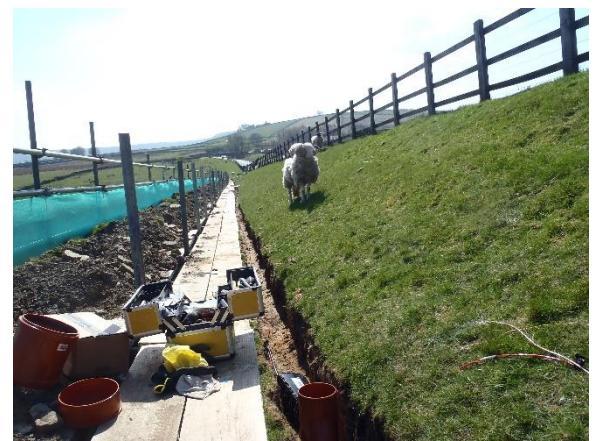
Installation of the fibre optic cable at the Digley Reservir Embankment

Near the Riding Wood Reservoir is the **Digley Reservoir**. Since its construction in 1953 the 50 m high earth fill dam with the clay core subsided significantly. In October 2014, 13 temperature probes were installed permanently downstream along 192.8 m of the slope in order to start long-term measurements. The monitoring system was installed in order to detect possible seepage water passing through the embankment. Therefore, 505 m of fibre optic cable was used for the Gradient-Method and the Heat-Pulse-Method. The temperature soundings are approximately 5 m from the downstream edge of the crest and were rammed into the downstream slope of the dam to a depth of up to 29 metres. The installed monitoring system has an accuracy of ± 0.5 m and ± 0.1 K.

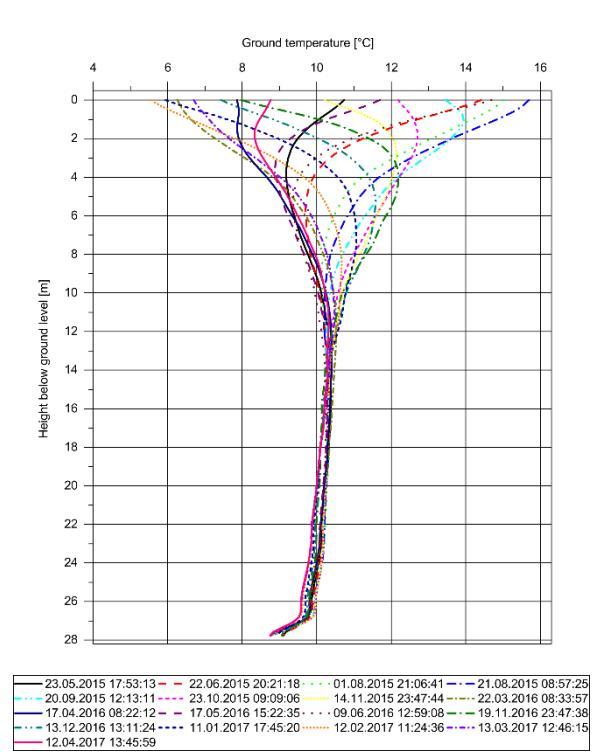
Selected temperature-depth profile for a period of 2 years for the soundings T3 at the Digley Reservoir

A reference measurement was carried out in April 2015, where no leakage was detected. In the future, changes in the leakage behaviour can be detected during subsequent control measurements. The following diagram shows the temperature depth profiles of the sounding T3 for selected dates for a period of 2 years. The sounding T3 shows the temperature profile of a non-percolated dam. In the upper 10 m of the sounding you can see the seasonal temperature fluctuations, which decrease in amplitude with the depth.
