# Dam Leakage Detection and Monitoring

## Macedonia

A rockfill dam with an asphalt core required leakage detection and seepage monitoring using GTC Kappelmeyer's Fiber Optic Leakage Detection method with an AP Sensing DTS (Distributed Temperature Sensing) device.

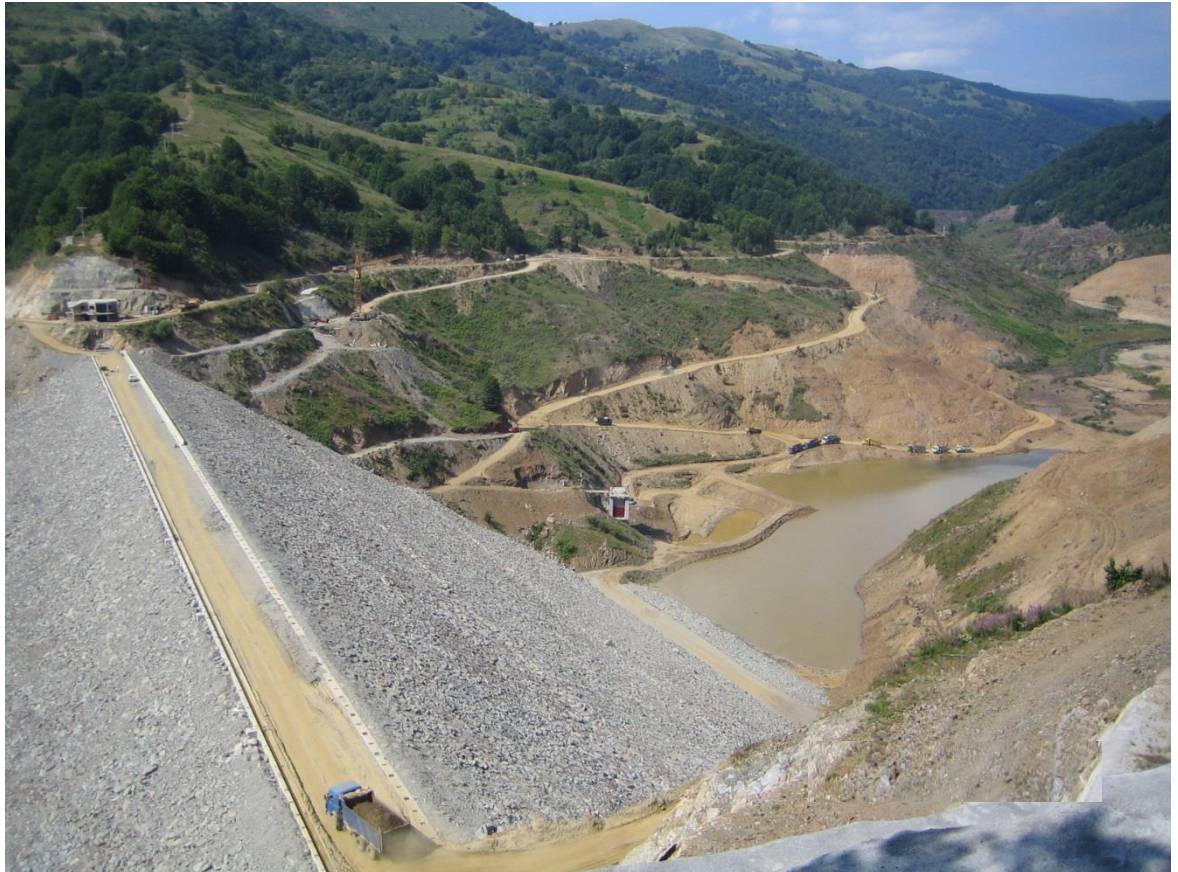
*Knezovo Dam: late construction phase*

In order to solve water-supply problems in six municipalities in eastern Macedonia, a major dam project was commissioned: the Knezevo dam. The rockfill dam with an asphalt core is 75 meters high and 300 meters wide at the base. Its storage facility is 4 km long and it has a maximum accumulation of 23.5 million cubic meters of water.

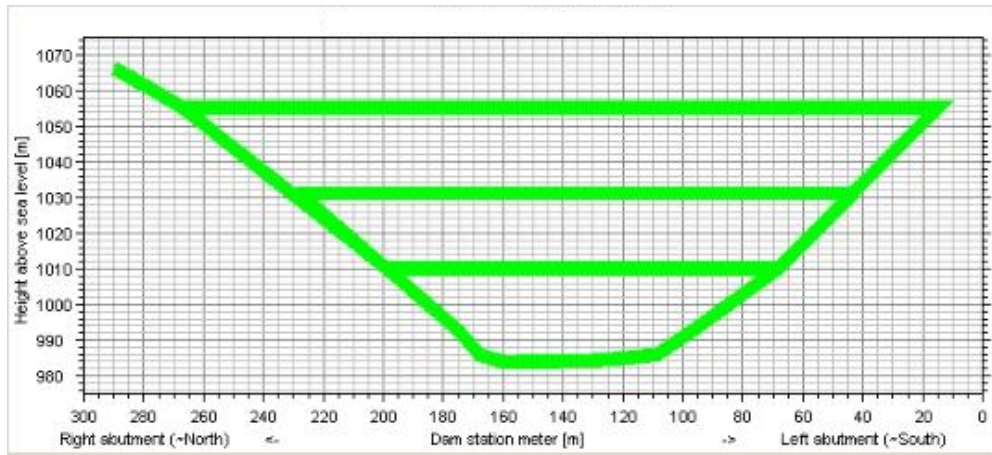
A dam of this size and importance needs to be monitored for leakage. The following diagram shows the most efficient pattern to use for the sensor cable layout. The cable was installed on the downstream side of the interior asphalt core, inside the filter zone.

*Diagram of the fiber optic sensor cable layout*

Approximately 1200 m of sensor cable was required. The type of cable selected was the hybrid sensor cable, which makes use of multimode sensor fibers together with copper wires in the tube to facilitate controlled heating and cooling. In this case the copper wires have about 11 W/m heat output and 4 heating cycles are carried out daily.

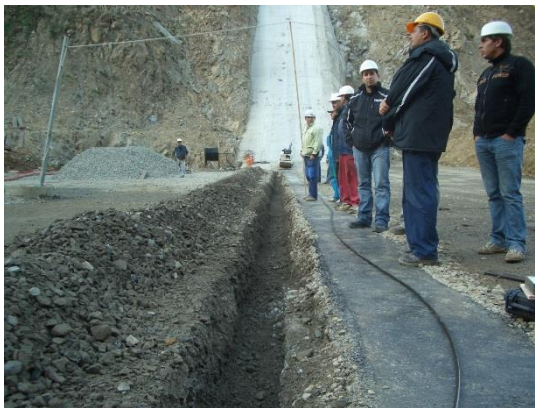
*Cable installation*

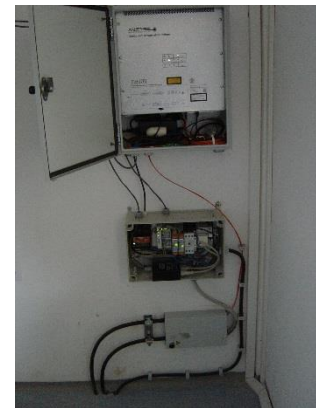
*Interior DTS installation*

Both the DTS device and the Heat-Pulse control unit make use of the ModBus protocol and are connected to the local network via TCP/IP. The AP Sensing DTS Configurator and the customer-specific evaluation software are installed on a local PC.
